Manhole Inspection Summary

Manhole # S33E__049MH

Insp Date: **8/27/08 10:40 AM**

Location Address: **228 w lexington st**

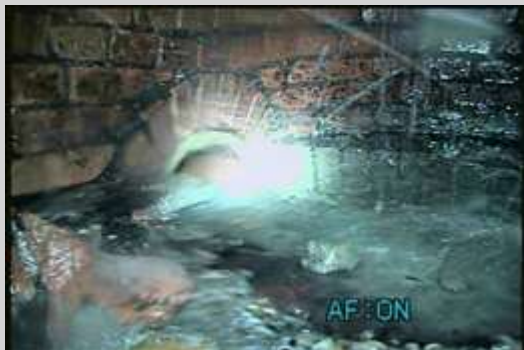
Drop In @ 12 OClock

15 in. Circular Gravity Sewer
Pipe Out @ 12 OClock

Drop: **Inside** **Direct**
Angled: Reading: **0.00** (ft.)
Inv Depth: **16.88** (ft.)
Drop Condition: **Open**

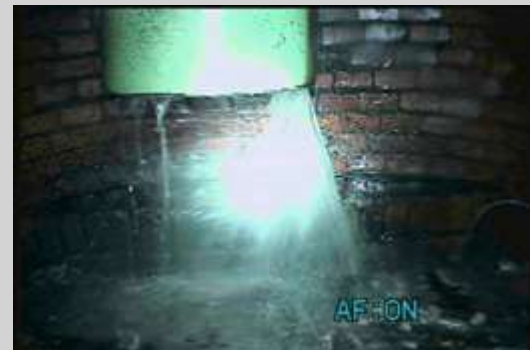
12 O'Clock Outflow

best shot for 12

Pipe Height: **0** (in.) Direct
Pipe Material: **Clay** ☐ Pipe Lined
Invert Depth: **15.50** (ft.) Flow Characteristics: **Fast**
Deposits: ☒ None ☐ Mud ☐ Sludge ☐ Debris ☐ Grease
Silt Depth: **0** (in.) Deposits Extent:
Infiltration: **None** Pipe Seal Cond: **Unknown**

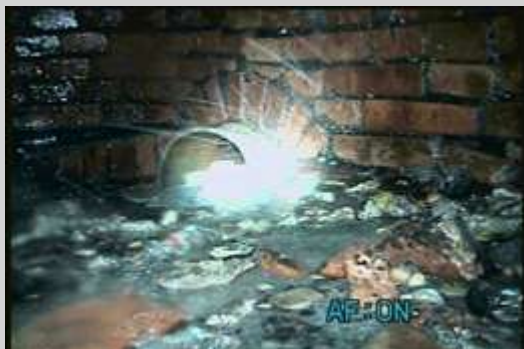
3 O'Clock Inflow

15 in. Circular Gravity Sewer
Pipe In @ 3 OClock

best shot for 3

Pipe Height: **0** (in.) Direct
Pipe Material: **Clay** ☐ Pipe Lined
Invert Depth: **16.83** (ft.) Flow Characteristics: **Fast**
Deposits: ☒ None ☐ Mud ☐ Sludge ☐ Debris ☐ Grease
Silt Depth: **0** (in.) Deposits Extent:
Infiltration: **None** Pipe Seal Cond: **Unknown**
